RECORDS

STEAM BOILER EXPLOSIONS,

EDWARD BINDON MARTEN,

MIDLAND STEAM BOILER INSPECTION AND ASSURANCE CO.

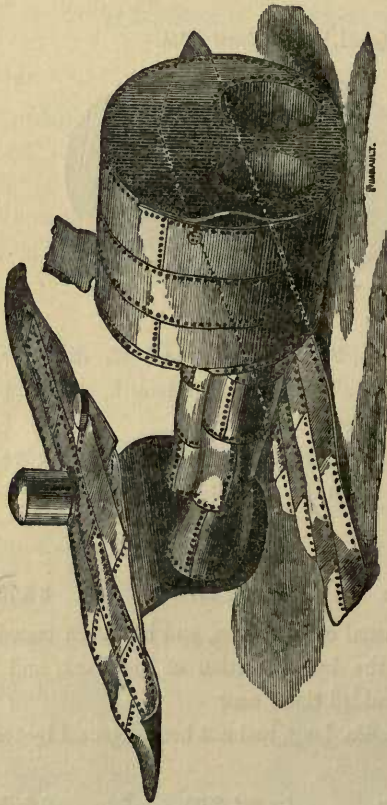
Fig. 22.

No. 50. *Chatham.* (Fig. 22.) September 7th. 2 killed, 30 injured.

Two Tube Cornish, 22ft. long, 7ft. 6in. diameter, with tubes, 3ft. diameter, $\frac{7}{16}$ inch plate, 60 lbs.

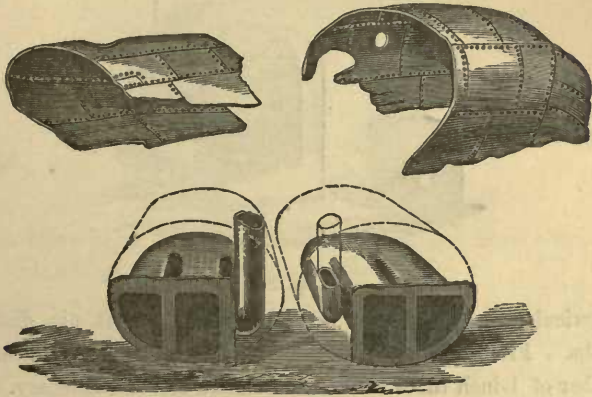
Fig. 26.

No. 59. Bristol. (Fig. 26.) November 1st.

Two Marine Boilers exploded simultaneously. They were 16ft. long, 6ft. 6in. diameter at the flat front ends, and somewhat less at the hemispherical back ends. Each had two internal fireplaces, united in one flue, which returned nearly to the front and passed up through the steam space, and out at the top of shell into the funnel. The central fireplaces were not circular, and the outside fireplaces and the return flues were still more distorted, but the weakness of the shape was somewhat compensated for by stays between the tubes, and from the tubes to the shell. The mountings to the boiler were of the ordinary kind and efficient.

The corrosion was no doubt caused by the leakage of the vessel, keeping the shells of the boilers constantly wet.

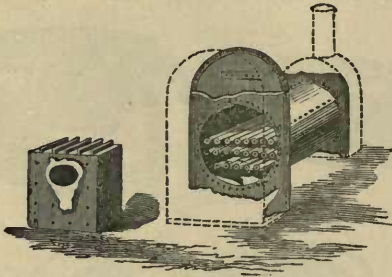
Fig. 27.

No. 60. London. (Fig. 27.) November 3rd. none injured.

Agricultural, barrel was 3ft. 9in. long, and 2ft. 6in. diameter, 70 lbs. From the internal fire-box the heat passed through a number of 1-inch tubes to the front smoke box and chimney.

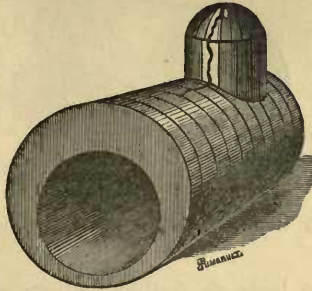
Fig. 28.

The boiler had been off for cleaning, and steam was being got up in the night, and it was said that an extra pressure was caused by

the stop valve being left closed, but it could not have been very great, or the large tube would have collapsed.

The dome was split in two, in the line marked in the sketch, owing to the extreme weakness of the shell at the juncture of the dome, and the shell was a little ruptured on each side of it, and so large a rent was suddenly made, that the contents of the boiler passed harmlessly into the air, without moving the boiler on its seat.

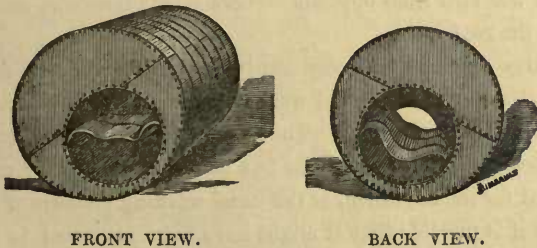
Fig. 29.

No. 62. Preston. (Fig. 29.) November 11th. 1 killed, 1 injured.

One Tube Cornish, 16ft. 3in. long, and 5ft. 8in. diameter, tube 3ft. 1in. diameter, $\frac{7}{8}$ inch plates, 60 lbs.

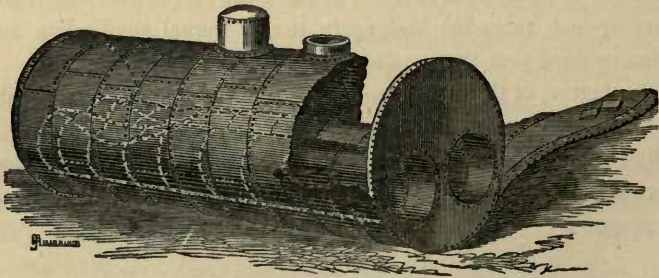
Fig. 32.

No. 69. *Manchester.* (*Fig. 32.*) *December 15th.* *5 injured.*

Two Tube Cornish, 24ft. long, 6ft. 6in. diameter, tubes 2ft. 8in. diameter, $\frac{7}{16}$ inch plates, 50 lbs. The boiler was fired in each of the tubes in the ordinary way, and also the heat from two furnaces passed from the back, one on each side of the outside shell.

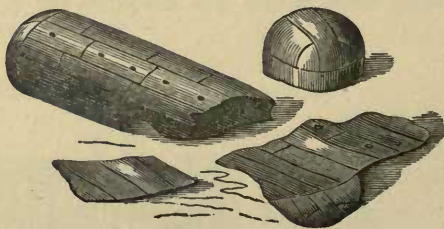
Fig. 1.

No. 2. *Durham.* (*Fig. 1.*) *January 2nd.* *3 killed, 3 injured.*

Plain Cylinder, 33ft. long, 6ft. diameter, 33 lbs. pressure. Only set two days, but was old and deteriorated, and had worked before at another place. It had been turned $\frac{1}{4}$ round, and old fitting-holes stopped. First rent was supposed to be in a seam at front end, over the fire. Main portion of shell was driven back, and front end forward, and torn in its flight. The cause of explosion was, that the seam in front was overheated and injured, and also incautious working without a steam guage.

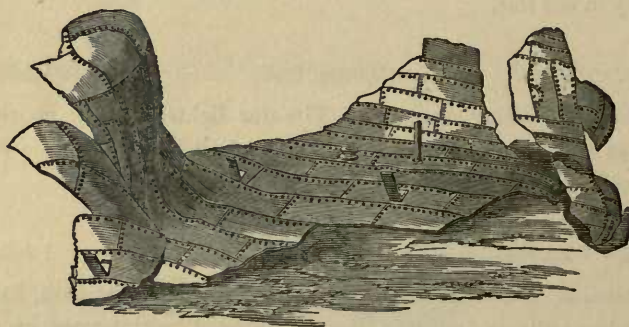
Fig. 3.

No. 10. *Sunderland.* (*Fig. 3.*) *January 26th.* *3 injured.*

Plain Cylinder, 30ft. long, 6ft. 2in. diameter. Pressure 30 to 35 lbs. Rent into four pieces, which were flattened out and scattered on to other boilers, but are arranged in sketch so as to show their original position in the boiler. It had worked a very long time, and was overheated and injured along the fractured line.

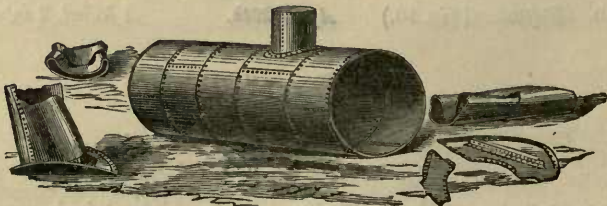
Fig. 13.

No. 23. *Newark.* (Fig. 13.) *May 18th.*

Cornish, one tube 20ft. 6in. long, 5ft. 4½in. diameter, tube 3ft. diameter, plates $\frac{3}{8}$ inch, pressure 64 lbs. The ends came out and tube collapsed for its full length, every joint being broken. The cause of explosion was bad construction and workmanship, and tube too weak for pressure.

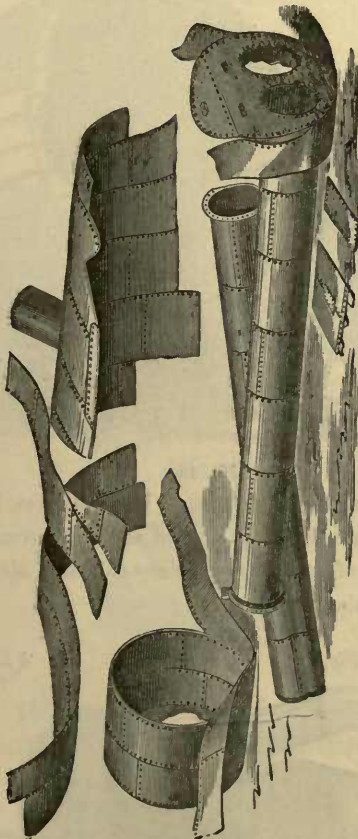
Fig. 14.

No. 24. Tamworth. (Fig. 14.) June 4th.

Two tube, externally fired, 30ft. long, 7ft. diameter, tubes 2ft. 4in. diameter, pressure 50 lbs. Two plates lately put in bottom gave way, and shell rent along bottom and opened out, dividing into

several pieces, which were scattered to great distances, but are arranged in sketch so as to show their original position. The cause of explosion was too frequent repair over the fireplace, and external firing.

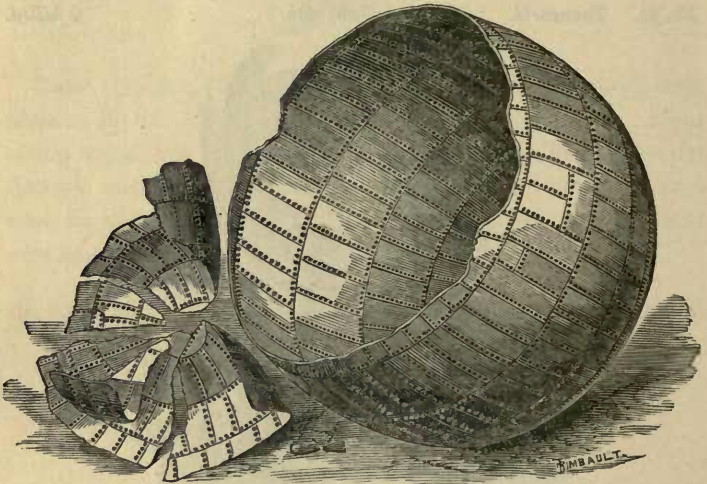
Fig. 15.

No. 25. *Dudley.* (Fig. 15.) July 10th. 1 killed, 2 injured.

Balloon, 22ft. diameter, pressure 5 lbs. Bottom blew out and was torn in pieces. Main portion of shell fell over on to another boiler. The cause of explosion was deep corrosion along the bottom where it rested on the brickwork.

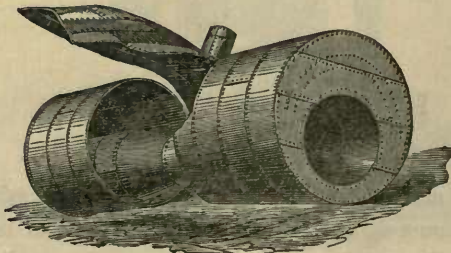
Fig. 16.

No. 26. *Batley.* (Fig. 16.) July 11th. 3 killed, 3 injured.

One tube Cornish, 26ft. long, 8ft. 10½in. diameter, tube 5ft. diameter, for 8ft. 6in. of front end, tapering to 4ft. diameter at back, pressure 30 lbs. Rent along bottom, allowing central ring of plates to open out. The whole boiler was thrown some distance by the reaction of issuing contents. The cause of explosion was corrosion at mid-feather wall, the plates being little thicker than paper.

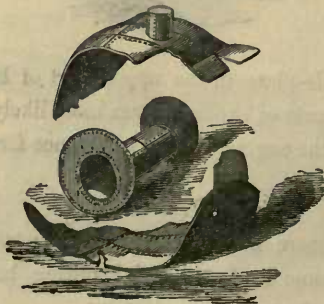
Fig. 20.

No. 34. *London.* (Fig. 20.) *October 7th.* *1 killed.*

One tube Cornish, 11ft. long, 4ft. diameter, plates $\frac{3}{8}$ inch, tube 2ft. 1 $\frac{1}{2}$ in. diameter, pressure 50 lbs. Gave way underneath. Top thrown upwards. Front part and tube thrown to the front. The cause of the explosion was extensive corrosion at the bottom where it touched the walls.

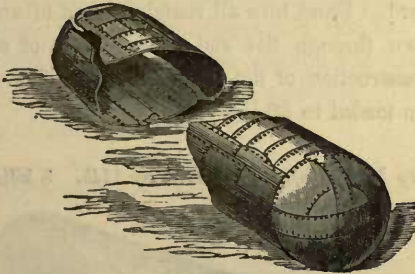
Fig. 21.

No. 36. *Durham.* (*Fig. 21.*) *November 3rd.* *1 killed, 1 injured.*

Plain Cylinder, 19ft. long, 6ft. diameter, pressure 40 lbs. It was 36 years old, and iron deteriorated and also much patched. The cause of explosion was over-pressure for so old a boiler.

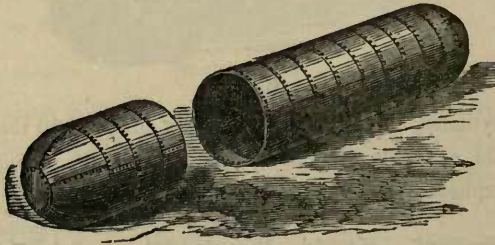
Fig. 24.

No. 39. *Langley Mill.* (Fig. 24.) *November 11th.* 3 killed, 10 injured.

Plain Cylinder, 40ft. long, 5ft. diameter, plates $\frac{7}{16}$ inch, pressure 45 to 50 lbs. Parted at third seam, and front thrown forward and main portion backwards. The cause of explosion was a seam-rip of old standing near patch at place of first rupture.

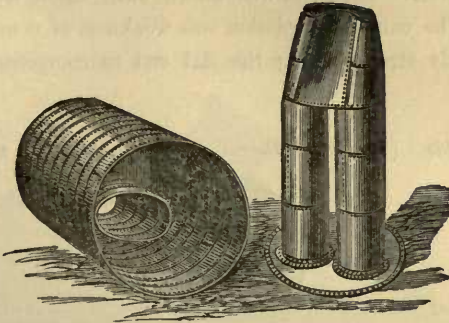
Fig. 25.

were thrown to the front in one piece. Main shell not injured. Back part of tube remained in boiler. Bottom part of taper

junction where flattened to receive the two fire tubes, collapsed upwards. The cause of explosion was the want of proper stays or strengthening tubes, and consequent weakness. There was only one safety valve of small size.

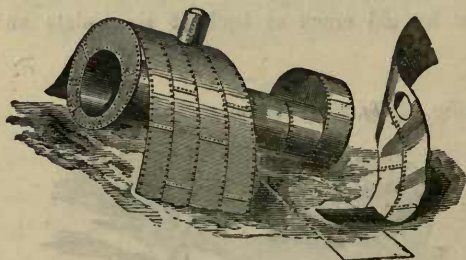
Fig. 29.

No. 45. *Manchester.* (Fig. 29.) *December 23rd.* *6 killed, 4 injured.*

One tube Cornish, 18ft. long, 6ft. diameter, tube 3ft. 2in. diameter, plates $\frac{3}{8}$ inch. Pressure 25 lbs. Rent along bottom, and two rings

of plates blown away, but tube and ends not much injured. The cause of explosion was extensive corrosion on the part resting on the midfeather wall.

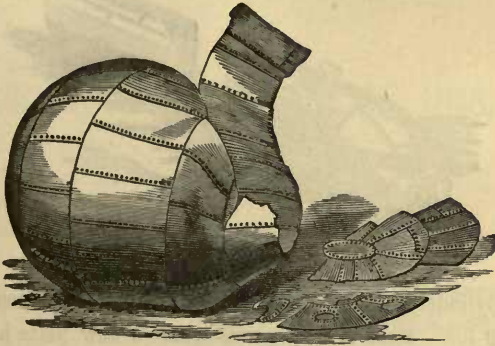
Fig. 30.

No. 46. *Barnsley.* (*Fig. 30.*) *December 28th.*

Balloon, 11ft. 6in. diameter, and 11ft. 6in. high, plates $\frac{3}{8}$ inch. Bottom domed up 3ft. 6in. over fire; ordinary pressure 8 lbs. Boiler had worked two days at 25 lbs. pressure, but safety valve loaded to 16 lbs. The cause of explosion was undue pressure for an old boiler of such weak shape.

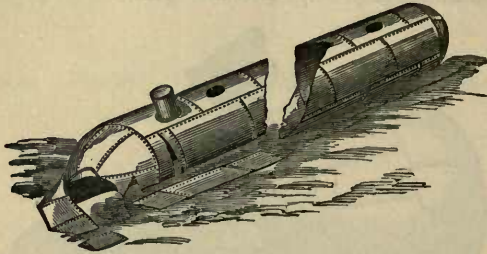
Fig. 32.

No. 48. Shields. (Fig. 32.) December 31st. 2 killed, 1 injured.

Plain Cylinder, 30ft. long, 4ft. 6in. diameter, plates $\frac{3}{8}$ inch, pressure 29 lbs. Rent over fire near where a new plate had lately been put in. Front part of shell opened out and rent, and back end blew away in one piece. The cause of explosion was deterioration from 20 years' wear, and bad management.

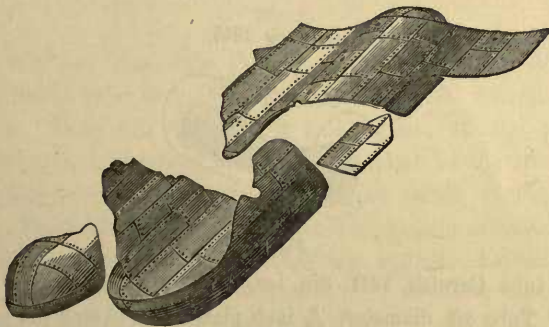
Fig. 1.

No. 1. *Newcastle.* (*Fig. 1.*) *January 13th.* *none injured.*

One of three. Plain Cylinder, 27ft. long, 5ft. diameter, $\frac{3}{8}$ inch plates, 35 lbs. pressure. The boiler was much torn up, and all the fragments thrown to the front of their original position. The cause of the explosion was that the boiler was very old and much deteriorated, so that it was unable to bear the ordinary pressure. The longitudinal arrangement of the plates, and the entrance of the feed directly on the bottom, no doubt contributed to the weakness.

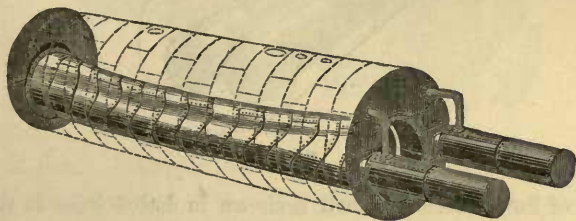
Fig. 5.

No. 6. *Stoke.* (Fig. 5.) February 6th. none injured.

One of three. One tube Cornish, with two external fire grates with a water tube over each fire. It was 30ft. 2in. long, 6ft. diameter. Tube 3ft. diameter, $\frac{3}{8}$ inch plates, 40 lbs. pressure. External shell is shown in dotted lines to allow of the tubes being seen. The tube had formerly been placed rather higher in the boiler. The tube collapsed sideways, having become overheated from shortness of water. The boiler itself was but little disturbed.

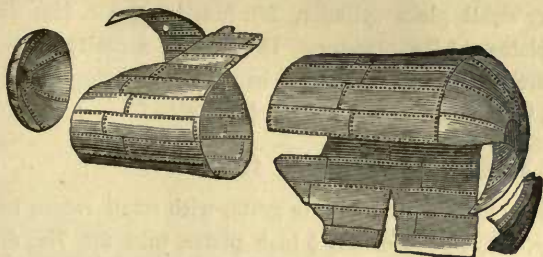
Fig. 9.

No. 10. Newcastle. (Fig. 9.) April 4th. 1 killed, 4 injured.

One of four. Plain Cylinder, 28ft. long, 6ft. diameter, $\frac{3}{8}$ inch plates, 30 lbs. pressure. The boiler was much torn and scattered, and much damage was done. The plates were improperly arranged longitudinally. The boiler gave way at a patch lately put on, and had become so deteriorated by nearly 30 years' wear, that it was unable to bear the usual pressure.

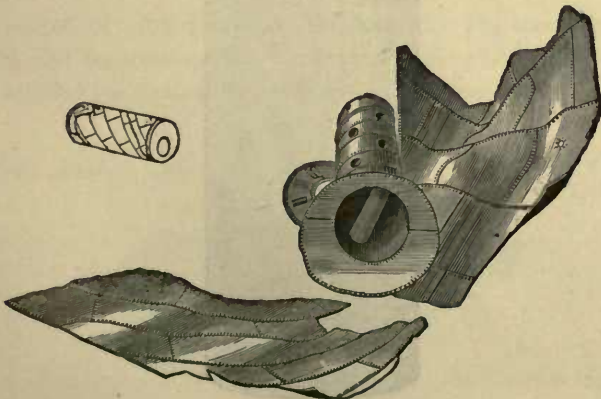
Fig. 13.

No. 21. *Huddersfield.* (Fig. 13.) *June 20th.*

One tube Cornish, 24ft. long, 6ft. diameter. Tube 3ft. 3in. diameter, $\frac{3}{8}$ inch plates, 40 lbs. pressure. The seams were arranged diagonally, but the rents had not followed the seams, but had torn the plates. The shell gave way where extensive corrosion had reduced the plates to $\frac{1}{8}$ inch in thickness, and all the shell was blown off, and the tube thrown over and turned end for end.

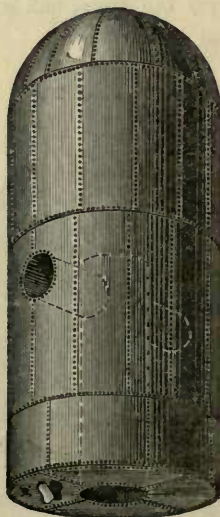
Fig. 14.

No. 24. *Wrexham.* (*Fig. 14.*) *July 9th.* *2 injured.*

Two Furnace Upright, 22ft. high, 8ft. 10in. diameter, $\frac{3}{8}$ inch plates, 14 lbs. pressure. Small piece was blown out of the bottom, and the issuing contents disturbed the brickwork surrounding the boiler. The plate was corroded to a knife edge in the line of fracture, from the leaking of the adjacent blow-pipe joint.

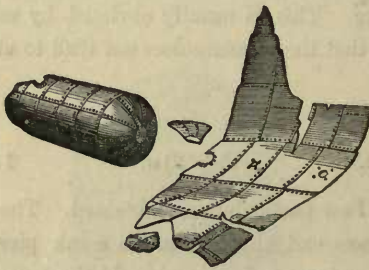
Fig. 16.

No. 30. *Bilston.* (Fig. 16.) August 17th. 1 killed.

One of two. Plain Cylinder, 30ft. long, 5ft. diameter, $\frac{3}{8}$ inch plates, 46 lbs. pressure. The boiler gave way on the side where the plates were overheated by the water being too low, and the front part of the shell was flattened out and thrown some distance to the rear, as its course was influenced by its remaining attached to the rest of the boiler as by a hinge; while the front end was rent into several pieces, and the back end was thrown also to the rear and rolled down a declivity into a stream.

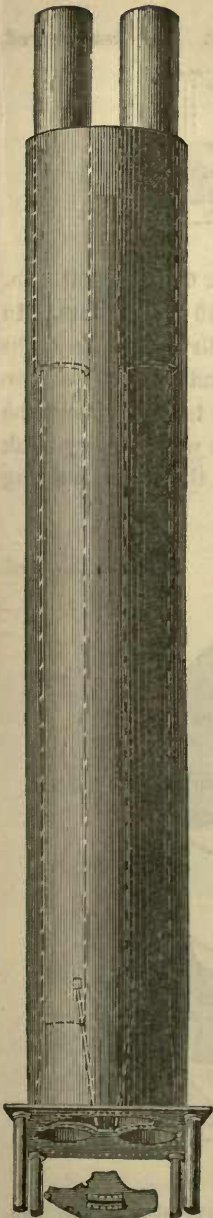
Fig. 17.

Two tube Cornish. The manlid was wrongly fixed outside with internal clamps. It was being screwed up tighter to stop leaking when the bolt broke, and the lid came off and allowed the contents of the boiler to escape.

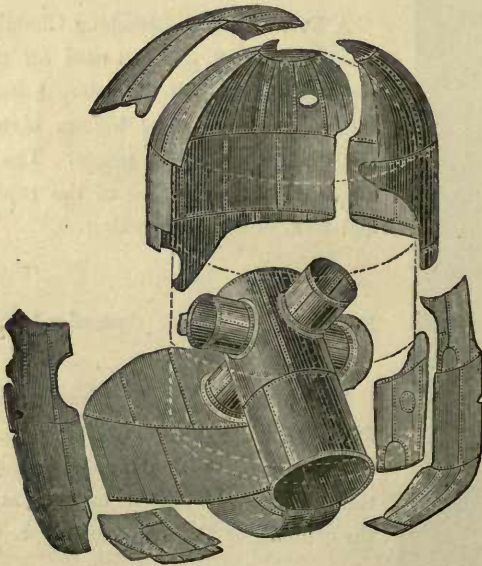
Fig. 19.

No. 35. *Moxley.* (Fig. 19.) *September 28th.* *13 killed, 2 injured.*

One of four. Four Furnace Upright, 22ft. high, 10ft. 6in.

diameter, $\frac{7}{8}$ inch plates, 40 lbs. pressure. The boiler was rent into nine pieces, one of which was not found. The dotted line in sketch shows the outline of the boiler before explosion, and the fragments are arranged as nearly as possible in their original position. The first rent was at a seam-rip opposite the largest furnace, from whence the rupture opened in every direction. This seam-rip must have existed some time before explosion, and must have extended from rivet to rivet, until the boiler was so much weakened as to be unable to bear the usual pressure.

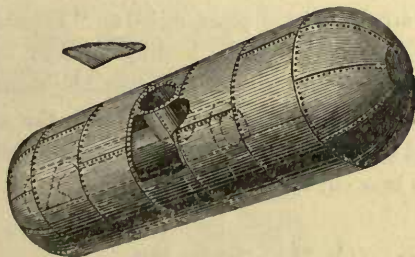
Fig. 20.

No. 37. *Elsecar.* (*Fig. 20.*) *October 2nd.* *2 killed.*

One of four. Two Furnace Upright, 21ft. high, 7ft. diameter, $\frac{7}{8}$ inch plates, 58 lbs. pressure. A large piece of plate was blown out of the side of the boiler, and the reaction of the issuing contents threw the boiler over on to its side. The plate was said to be overheated from shortness of water, but as the centre tubes were uninjured, the ruptured plate may have become overheated from the intense heat impinging on one place, causing so rapid a generation of steam as to prevent proper contact of water.

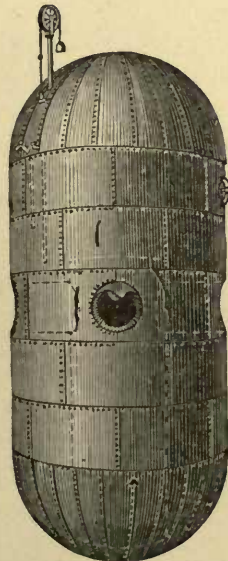
Fig. 26.

One of eight. Four Furnace Upright, 22ft. high, 9ft. diameter, $\frac{7}{8}$ inch plates, 45 lbs. pressure. The water was allowed to get so low that the shell was overheated and rent, and the side tube slightly collapsed, and the injury was not discovered until the feed water had risen up to the rupture, when it ran into the furnaces without causing any violent explosion, although cold water had been put into a red hot boiler.

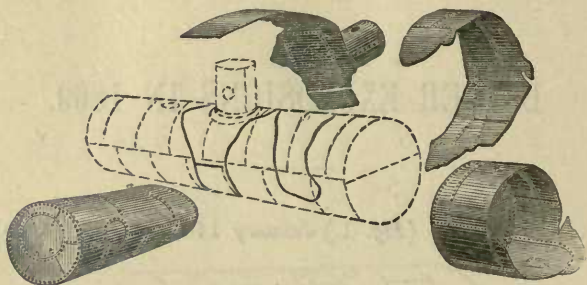
Fig. 3.

No. 3. Greatbridge. (Fig. 3.) January 26th. 1 killed, 1 injured.

One of two. Plain Cylinder, with flat ends, 22ft. long, 4ft. 3in. diameter, $\frac{3}{8}$ inch plates, 60 lbs. pressure. There had formerly been a tube with internal furnace, and this had been removed without sufficient stays to compensate for the loss of strength. The plates were arranged in the weakest way with seams in one line from end to end, and the strength of the boiler had been further reduced by very frequent patching. Fracture commenced about the centre of the long seam under the dome, which had gradually ripped from rivet to rivet, until unable to bear the ordinary pressure. The boiler exploded because it was completely worn out, and shows how treacherous and uncertain a boiler becomes by constant patching and alteration. See also No. 45.

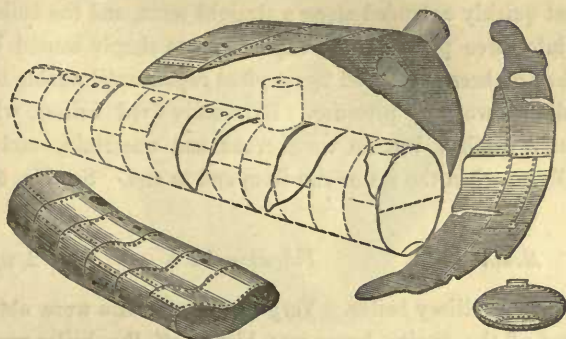
Fig. 4.

some of the fragments cut up, but enough particulars were obtained to give some idea of the nature of the explosion.

The first rent must have taken place in the bottom seams over the fire, where weakened by frequent repair.

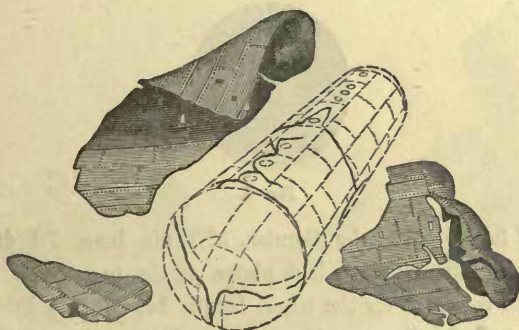
Fig. 5.

No. 5. Durham. (Fig 5.) February 2nd. 1 killed, 4 injured.

One of twelve. Plain cylinder, 13 years old, 30ft. long, 6ft. diameter, $\frac{3}{8}$ inch plates, 35 lbs. pressure. The plates were arranged lengthways, so that the seams were in continuous lines from end to end. This has often been mentioned as giving far less strength than where the plates are placed in rings. There had been considerable repair at various times, and just previous to explosion the boiler had been placed as was supposed in thorough repair, and some new

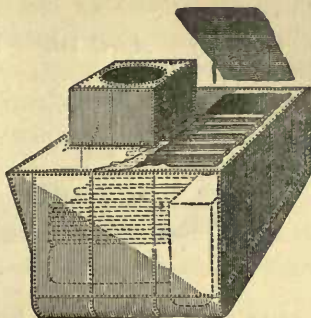
Fig. 7.

The boiler had also been much weakened by altering it from a round to a flat top without sufficient stays.

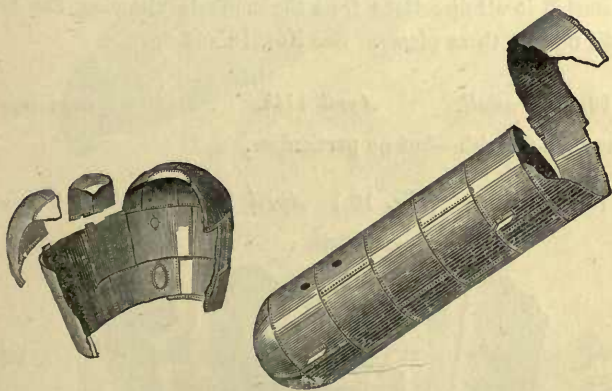
Fig. 8.

No. 10. West Bromwich. (Fig. 8.) March 9th. 3 injured.

One of two. Plain cylinder, 25ft. long, 4ft. 6in. diameter, $\frac{3}{8}$ inch plates, 42 lbs. pressure. The boiler had been very frequently repaired, and a seam gave way where a large patch had just previously been put on over the fire, in doing which the rivet holes of the old work had evidently been cracked, rendering the boiler unable to bear the usual working pressure. See No. 45.

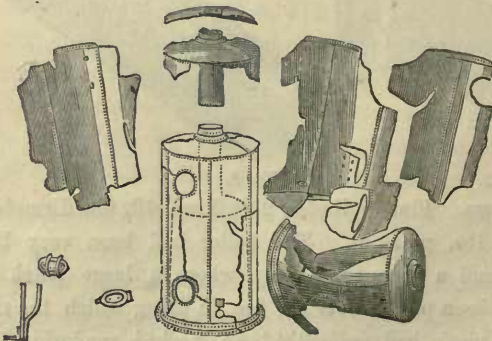
Fig. 10.

No. 14. *Barking.* (*Fig. 10.*) *April 19th.* *4 killed, 2 injured.*

Portable Crane, 8 years old, 8ft. 3in. high, 4ft. 4in. diameter, with internal fire box, 6ft. high and 3ft. 6in. diameter, and chimney passing out at the top, $\frac{5}{8}$ inch plates, 40 lbs. pressure. The internal fire box crushed in sideways, and the shell was rent into several pieces. The attachment of the fire box to the shell was made by bending the plates, as shown in enlarged sketch, and this is not so rigid as double angle iron and had evidently strained the chimney tube. This weakness had been so increased by deep corrosion just at the bend of the plates that it had given way. The havoc and loss of life was far greater than would have been supposed possible from so small a boiler, but similar cases are mentioned in No. 43, 1868, and No. 57, 1866.

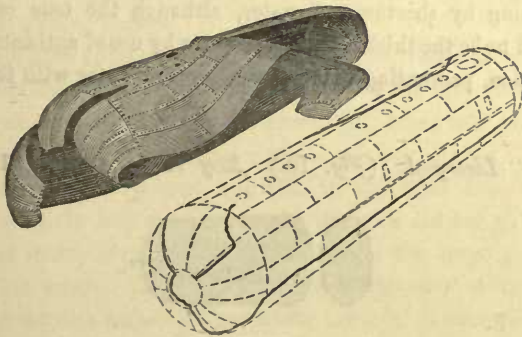
Fig. 11.

No. 15. *Durham.* (Fig. 11.) *April 23rd.* *none injured.*

One of two. Plain cylinder, with plates arranged lengthways, 30ft. long, 6ft. diameter, $\frac{3}{8}$ inch plates, 9 lbs. pressure. A seam gave way on the right side over the fire and immediately rent along the straight seam from end to end, and the boiler was thrown in one mass a great distance to the left. The boiler was very old and much weakened by frequent repair, and at the time of explosion was being imprudently worked at twice its usual pressure for a temporary purpose. See No. 59.

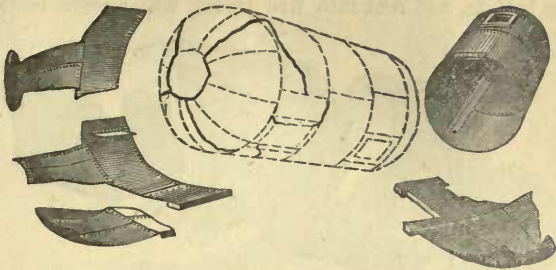
Fig. 14.

No. 18. *Abingdon.* (Fig. 14.) *May 13th.* 2 killed, 2 injured.

Revolving Rag boiler, 16ft. long, 6ft. diameter, $\frac{7}{16}$ in plates. There was no fire applied to the boiler itself, but it received steam through one end from other ordinary boilers at 50 lbs. pressure. There were two large rectangular manholes for putting in and taking out the rags, with cast iron frames and lids, attached by bolts with large nuts or clamps.

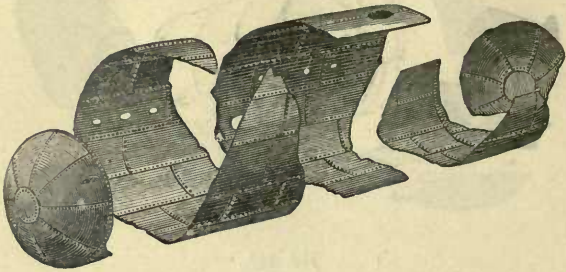
Fig. 15.

pressure. The boiler gave way at one of the long straight seams near the bottom, and rent into five pieces, which were scattered to

wide distances, but are so drawn in sketch as to show whereabouts in the boiler they came from. The boiler had been weakened by frequent repair until unable to bear the ordinary pressure. See No. 59.

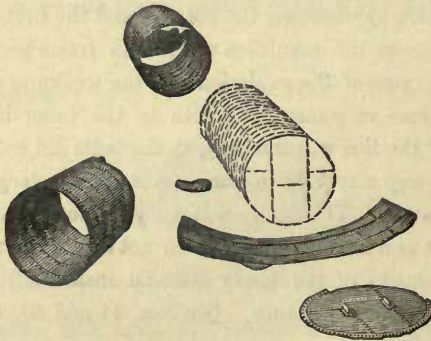
Fig. 16.

No. 21. South Wales. (Fig. 16.) May 31st. 5 killed, 4 injured.

One of three, very old, plain Cylinder, with flat ends, 34ft. long, 6ft. diameter, $\frac{3}{8}$ inch plates, 40 lbs. pressure. There had formerly been a tube through the boiler, and when this was taken away new flat ends had been put in without sufficient stays to compensate for the loss of the tube. The front end was blown out, and the reaction sent the boiler upwards and broke it into three pieces. See No. 47.

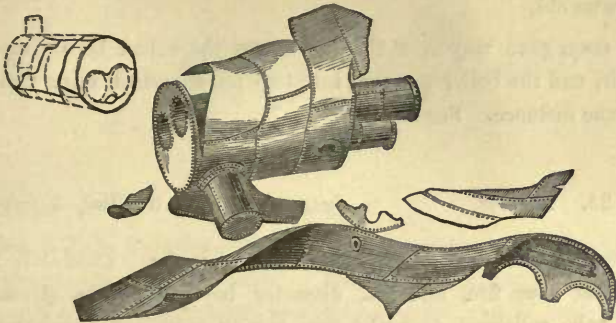
Fig. 17.

No. 22. *Bingley.* (Fig. 17.) *June 9th.* 15 killed, 33 injured.

Two tube Cornish, 16ft. long, 6ft. 9in. diameter, $\frac{7}{16}$ inch plates, 50 lbs. pressure. Tubes 2ft. 6in. diameter. The bottom was so much corroded that it rent open, and the boiler was torn to pieces which were scattered to wide distances. The boiler had been much neglected and badly used, and the safety valve was insufficient, of bad construction, and overloaded, and the alarm whistle was gagged.

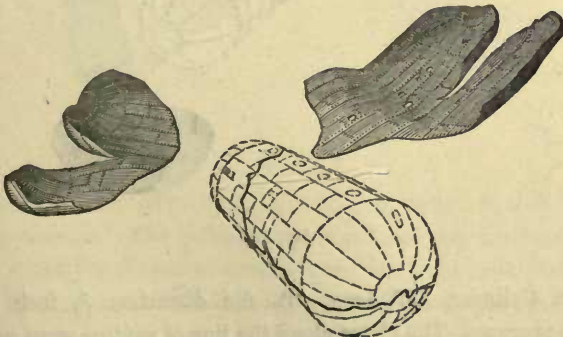
Fig. 18.

No. 24. *Durham.* (Fig. 18.) *June 16th.* 3 killed, 1 injured.

One of three. Plain Cylinder, with plates arranged lengthways,

A seam gave way over the fire where there had been frequent repair, and the boiler was rent into two pieces, which were thrown to some distance. See No. 59.

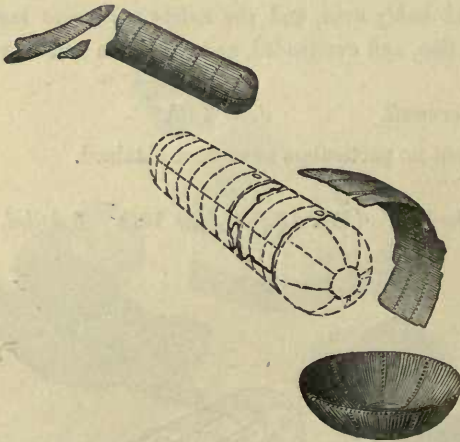
Fig. 19.

No. 26. *Nuneaton.* (Fig. 19.) July 5th. 3 injured.

Plain Cylinder, 25ft. long, 4ft. 6in. diameter, $\frac{7}{16}$ inch plates, 25 lbs. pressure. The plates along the line of rupture were corroded to $\frac{1}{16}$ inch, and in some places much less, so that the boiler was quite unfit for the ordinary working pressure.

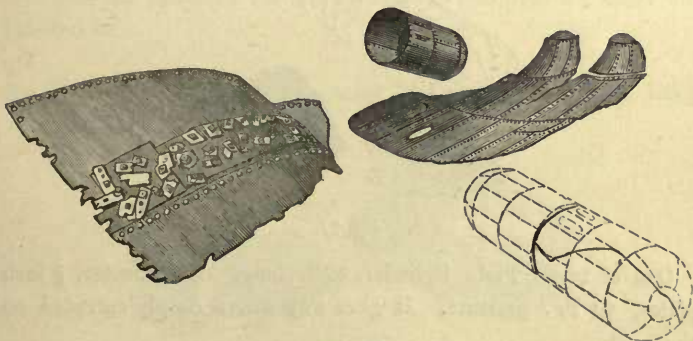
Fig. 21.

No. 29. *Kidderminster.* (Fig. 21.) *July 16th.* *1 killed, 4 injured.*

Plain Cylinder, 21ft. long, 4ft. 6in. diameter, $\frac{3}{8}$ inch plates, 50 lbs. pressure. The boiler was very old and very much corroded. It had slightly rent open at some former time, and a most wretchedly made patch, shown in enlarged sketch, had been put on to stop leaking, made of thin sheets of iron inside and out and pasteboard between, held together by 36 slight bolts. Of course this patch did not restore the strength of the boiler, and it soon leaked badly, and

the leaking hastened the corrosion of the plate below, until it was nearly eaten away, and quite unfit to bear the working pressure.

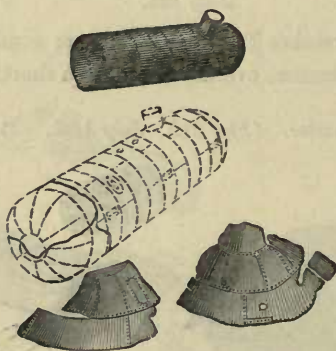
Fig. 22.

No. 31. *South Wales.* (Fig. 22.) July 19th. 1 killed.

One of two. Plain Cylinder, 32ft. long, 5ft. diameter, $\frac{3}{8}$ inch plates, 40 lbs. pressure. It gave way where deeply corroded on the inside.

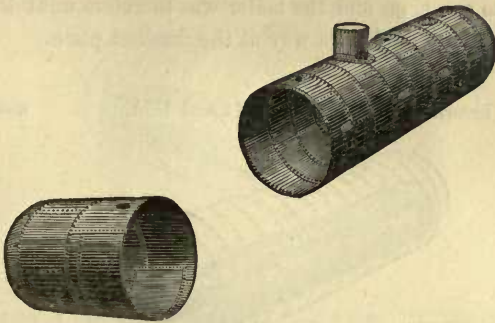
Fig. 23.

One of six. Plain Cylinder, 36ft. long, 6ft. diameter, $\frac{3}{8}$ inch plates, 50 lbs. pressure. Although the boiler was not an old one, it had been much repaired at the seams with strap plates. It was said that the water was very bad, and deposited much mud, which allowed the seams to get overheated and injured. The seam which

rent was an original one, and no doubt was ripped as the others had

been before repair, and that this rip extended from hole to hole until a rupture at the ordinary pressure was the result.

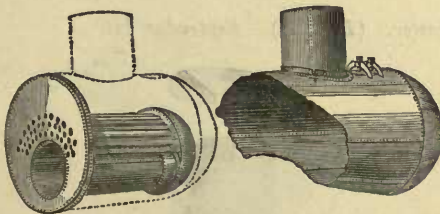
Fig. 24.

No. 34. London. (Fig. 24.) August 11th. 3 killed.

Marine, 8ft. long, 5ft. 6in. diameter, $\frac{3}{8}$ inch plates, 80 lbs. pressure. The flat front end gave way at the angle iron all round, allowing the front with tubes attached, and the shell to be thrown in opposite directions.

very defective and insufficient, and the angle iron was bad and not welded into one ring, and the boiler was therefore unfit to bear the ordinary pressure, and gave way at the weakest place.

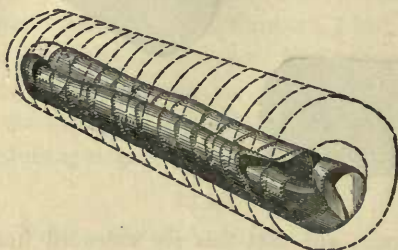
Fig. 25.

No. 35. *Cornwall.* (Fig. 25.) *August 16th.* *none injured.*

One tube Cornish, 32ft. long, 6ft. 6in. diameter. Tube 4ft. diameter, $\frac{7}{16}$ inch plates, 40 to 50 lbs. pressure. There was no steam guage.

The tube collapsed from end to end, both ends being torn, but the boiler was not moved from its seat. The fusible plug was uninjured. The cause of the explosion was the weakness of the large tube. See No. 57.

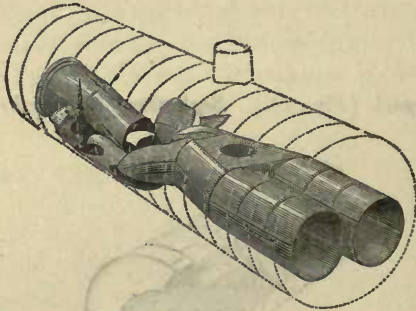
Fig. 30.

No. 40. *Hull.* (Fig. 30.) *September 16th.* 1 killed, 1 injured.

Breeches Tube, 13 years old, 30ft. long, 7ft. diameter. Furnace tube 2ft. 10in. diameter. Main tube 3ft. 5 $\frac{1}{2}$ in. diameter, and originally made to work at 20 lbs. pressure, but working lately at 45 lbs. The main tube collapsed. The boiler was not adapted for the pressure at which it was worked, and the tube was much weakened by the overheating caused by a thick incrustation of scale, and was not strengthened by any rings or stays, and was of very weak construction as the plates were arranged lengthways.

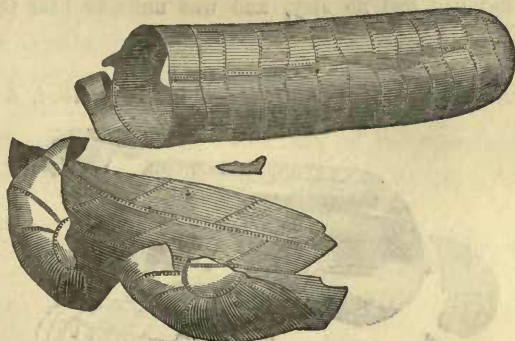
Fig. 31.

No. 41. *South Wales.* (Fig. 31.) *September 26th.* 1 killed, 1 injured.

One of two, 20 years old. Plain Cylinder, 36ft. long, 6ft. 6in. diameter, $\frac{9}{16}$ inch plates, 35 lbs. pressure.

The plates and rivet heads were very much reduced in thickness by internal corrosion, and in many places were only $\frac{1}{8}$ inch or less.

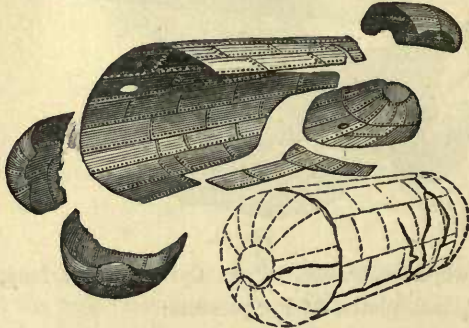
Fig. 33.

No. 44. Newcastle. (Fig. 33.) October 14th. 2 killed, 5 injured.

Plain Cylinder, with plates arranged lengthways, 29ft. long, 6ft. diameter, $\frac{3}{8}$ inch plates, 25 lbs. pressure.

Although only 3 years old the boiler had always given trouble, and had been very frequently repaired. Some new plates had just been put in the bottom, and as the primary rent was in the old plates adjoining them, it is most likely they had caused seam rips in the old metal.

The frequent repair had reduced the strength until unequal to bear the ordinary pressure. See No. 59.

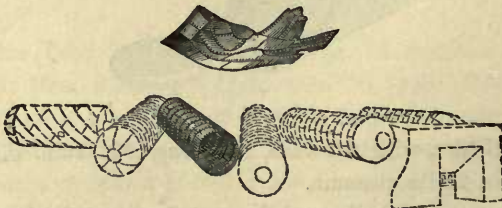
Fig. 34.

No. 45. Greatbridge. (Fig. 34.) October 18th. 2 killed, 2 injured.

One of eight, 15 years old. Plain Cylinder, 40ft. long, 6ft.

diameter, $\frac{1}{2}$ inch plates. The boiler had originally carried 60 lbs., but lately only 40 lbs. The boiler had been worked very hard, and had been so often repaired, that many of the seams were continuous for a long distance without break of joint, so that its strength was reduced until unable to bear the ordinary pressure.

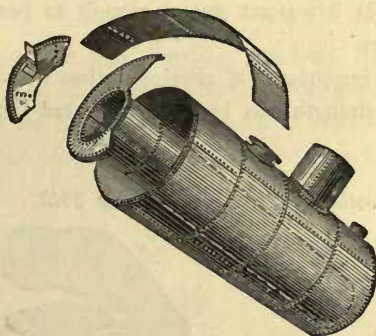
Fig. 35.

No. 46. Accrington. (Fig. 35.) October 19th. 2 killed, 3 injured.

One tube Cornish, 14ft. 6in. long, 5ft. diameter. Tube 2ft. 10in. diameter, $\frac{7}{16}$ inch plates, 40 lbs. pressure usually, and sometimes 60 lbs. One ring of plates was blown out of shell.

The boiler was so very badly corroded at the bottom, that the edges of the rent were quite sharp like a knife, and the boiler was therefore unable to bear the usual working pressure. The flues were too narrow to enter for proper inspection, and the bearing surfaces were too wide and retained moisture against the plates.

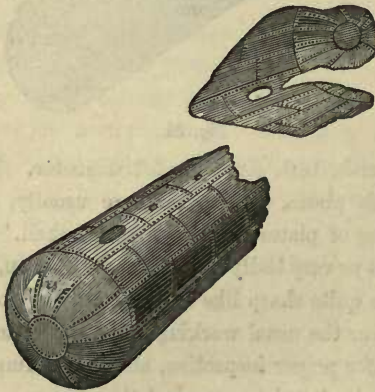
Fig. 37.

No. 48. Newcastle. (Fig. 37.) October 29th. none injured.

One of six. Plain Cylinder, with plates arranged lengthways, 40ft. long, 5ft. 3in. diameter, 40 lbs. pressure.

The boiler gave way at the fire end, and divided in two, and both pieces were blown to a great distance. The boiler was old and had been much repaired, and the seams running from end to end made it very weak, but the immediate cause of the rupture was supposed to be shortness of water and consequent overheating of the plates. See No. 59.

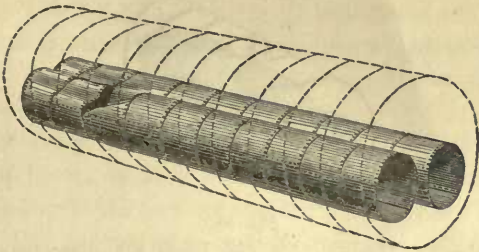
Fig. 38.

One of eight. Two tube Cornish, 30ft. long, 7ft. 4in. diameter. Tube 2ft. 11in. diameter, $\frac{3}{8}$ inch plates, 50 lbs. pressure.

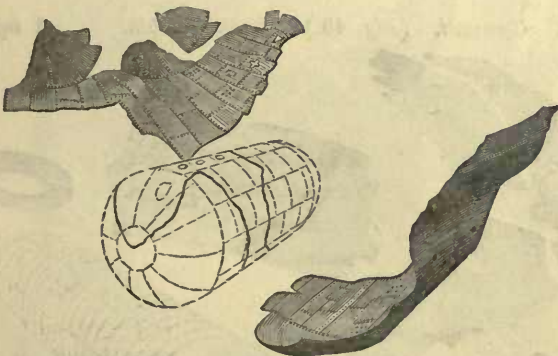
Fig. 39.

One of four. Plain Cylinder, with the plates arranged lengthways, 33ft. long, 6ft. 6in. diameter, $\frac{3}{8}$ inch plates, 35 lbs. pressure. A seam over the fire slightly to the right side gave way where there had been frequent repair to stop leaking. At the part which gave way there had formerly been a side fire, which had perhaps damaged the seams. This boiler was known to have been in bad condition and needing repairs. See No. 59.

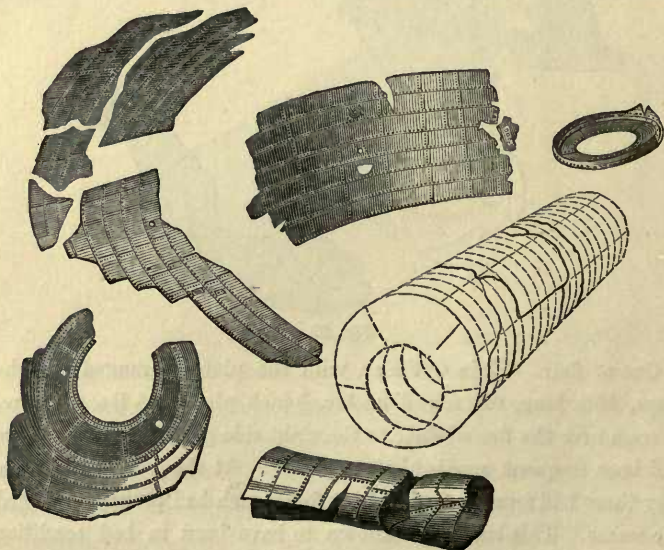
Fig. 41.

The shell was rent into several large pieces and thrown to some distance. The tube was also thrown out and broken, chiefly by its fall and striking against walls.

The boiler was corroded very badly on the seating, which must have been known, as there were numerous small screw patches to prevent leaking at the corroded places. The shell was in such bad condition, that it was quite unfit to bear the ordinary working pressure. See No. 58.

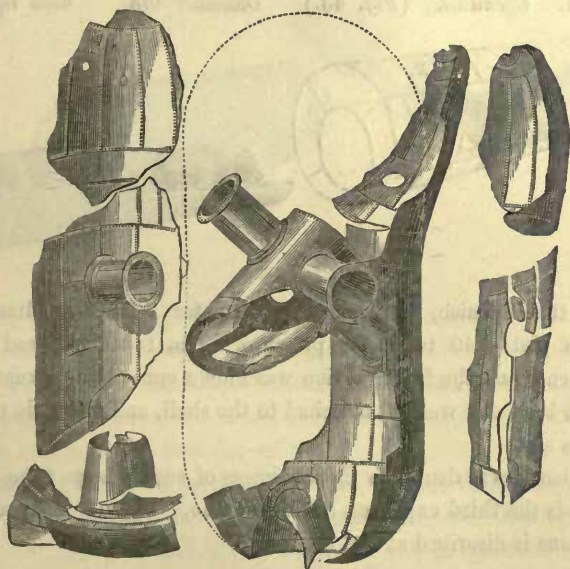
Fig. 42.

No. 53. *Bilston.* (Fig. 42.) *December 3rd.* 8 killed, 1 injured.

One of three. Four Furnace Upright, 20ft. high, 10ft. diameter. Centre tube 10ft. high, 4ft. 6in. diameter, side tubes 2ft. diameter, $\frac{3}{8}$ inch plates, 35 lbs. pressure.

and allowed the contents of the boiler to issue from the bottom into the culvert leading to the stack, and into the necks of the furnaces from which it was heated. The reaction sent the boiler up to a great height, and it divided into eleven fragments, which were very widely scattered. Comparatively little damage was done to the furnaces and premises, only the brickwork surrounding the boiler being thrown down.

Although it had only worked a short time at this place, it was very old, and the central tube was corroded until only $\frac{1}{8}$ inch thick in many places, and many of the rivet heads were quite eaten away. It was altogether so worn out that it was quite unfit to work at any pressure.

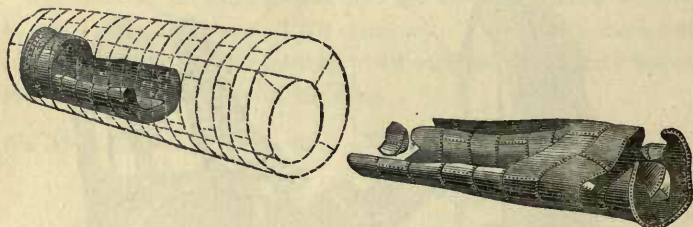
Fig. 43.

No. 54. Cornwall. (Fig. 43.) December 6th. none injured.

One tube Cornish, 32ft. long, 6ft. diameter. Tube 4ft. diameter, $\frac{1}{8}$ inch plates, 40 to 50 lbs. pressure. The tube collapsed from end to end, and the front portion was blown out with the front end, and the back end was left attached to the shell, and but little moved from its seat.

The cause was doubtless the weakness of such a large tube.

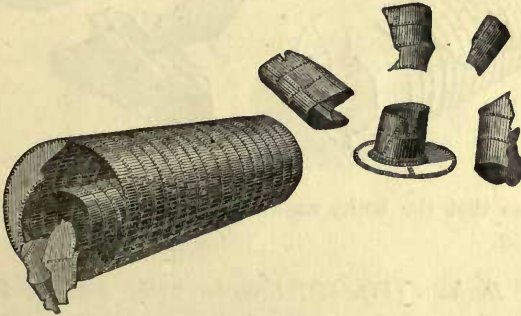
Fig. 45.

No. 57. Cornwall. (Fig. 45.) December 11th. none injured.

One tube Cornish, 32ft. long, 6ft 6in. diameter. Tube 4ft. diameter, $\frac{3}{8}$ inch plates, 60 lbs. pressure.

Many similar boilers have exploded in the same way from the same cause, as described in Nos. 28, 30, 35, 40, 54, and 56.

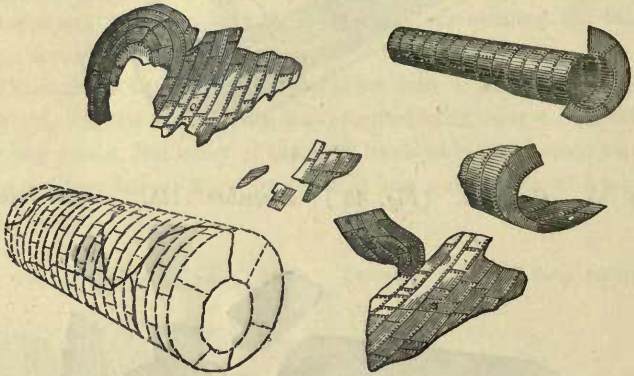
Fig. 46.

No. 58. Cornwall. (Fig. 46.) December 14th. 2 killed.

The shell was rent into several pieces, which were scattered to wide distances. The tube was also thrown to a great distance, but was uninjured. The boiler was 36 years old. The shell was very badly corroded, and temporarily repaired with screw patches to stop

leaking, so that the boiler was unfit to bear the usual pressure. See No. 52.

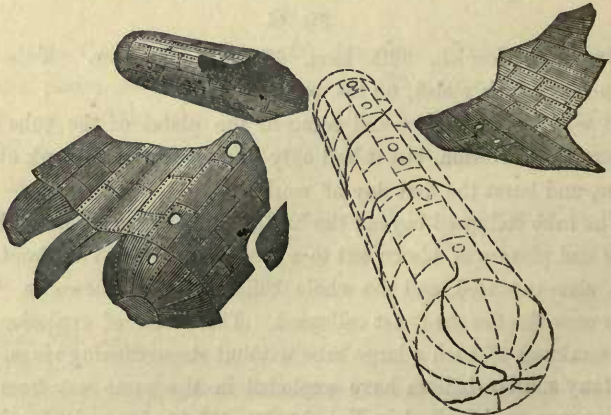
Fig. 47.

No. 59. *Durham.* (Fig. 47.) *December 29th.* 2 killed, 1 injured

One of three. Plain Cylinder, with plates arranged lengthways, 47ft. long, 6ft. diameter, $\frac{3}{8}$ inch plates, 30 lbs pressure. It gave

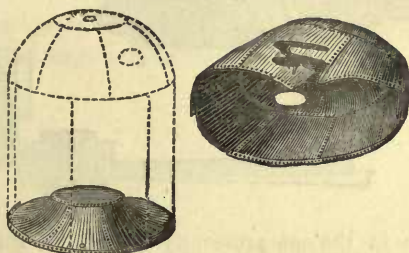
Tar Still, 10ft. high, 7ft. diameter, with round top and domed bottom, $\frac{3}{8}$ inch plates, and not intended to work at any pressure. The vapour passing away became congealed, and stopped up the small exit pipe, and pressure accumulated sufficiently to burst the weak shaped vessel.

The bottom came completely out and was left upon the fire, while the top ascended to a great height and fell a long distance away. The loss of life was owing to the material igniting and suffocating those who were thrown down by the explosion.

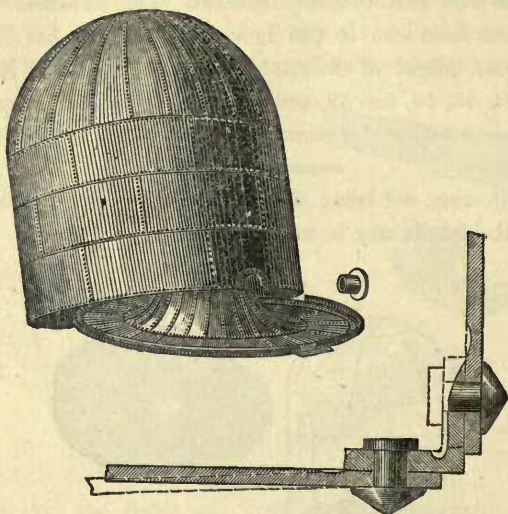
It was supposed that the intense frost, during a long stoppage for holidays, had caused the worm to be stopped up and pressure to

accumulate, as in the one previously described. But it is perhaps more probable that the vessel gave way because it was corroded so thin in so important a part as the angle iron. The explosion was very slight, the damage and loss of life being from the fierce fire which immediately succeeded it.

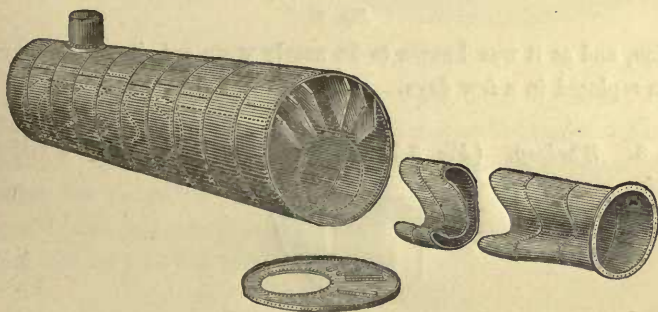
Fig. 1.

No. 1. *Newcastle.* (Fig. 1.) *January 7th.* 3 killed, 1 injured.

One of five. Cornish, 13 years old, 30ft. long, 6ft. 6in. diameter. Tube 3ft. 3in. diameter, $\frac{3}{8}$ inch plates, 30 lbs. pressure. Tube collapsed sideways from weakness, and the front part and the front plate were blown out, carrying the attendants into a deep and swollen river which ran close in front of boilers.

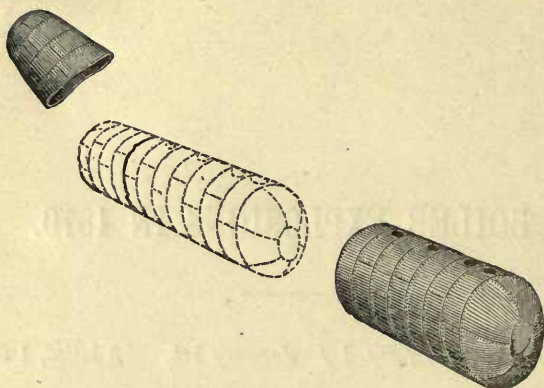
Fig. 2.

back end 150 yards to the rear, carrying away the stack. It had been badly repaired with bolted patches which had hastened cor-

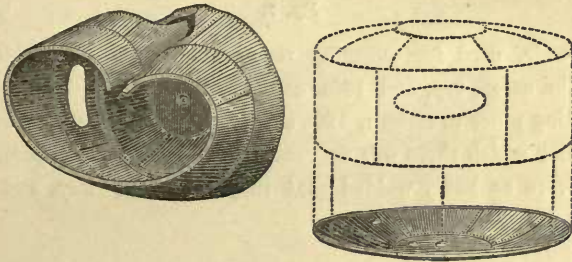
Fig. 5.

No. 5. Sheffield. (Fig. 5.) February 8th. 2 killed, 6 injured.

One of three. Rag Boiler, 2 years old, 11ft. diameter, 9½ft. deep, $\frac{7}{16}$ inch plates. Steam was supplied from the engine exhaust, and was usually about 10 lbs. pressure, but as the boilers from which the steam was originally supplied worked at 60 lbs., it is possible this was sometimes exceeded. The vessel was of very weak shape for even 10 lbs. pressure.

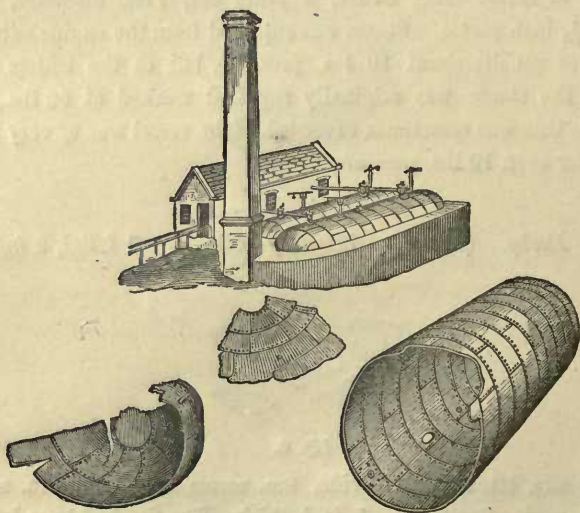
Fig. 8.

No. 8. *Walsall.* (Fig. 8.) *February 19th.* none injured.

One of two. Plain cylinder, 12 years old, 30ft. long, 7ft. diameter, $\frac{1}{2}$ inch plates, 50 lbs. pressure. The seams and plates

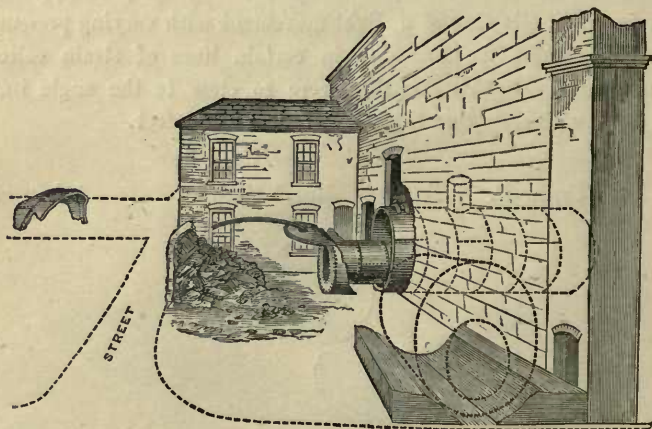
Fig. 12.

No. 12. *Portsmouth.* (Fig. 12.) *March 29th.* 3 killed, 1 injured.

One of two. Cornish, 9 years old, 22ft. long, 6ft. diameter.

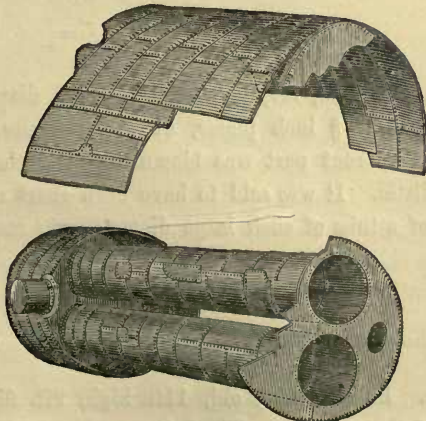
Fig. 13.

No. 14 *Warrington. (Fig. 13.) April 13th. 6 killed, 3 injured.*

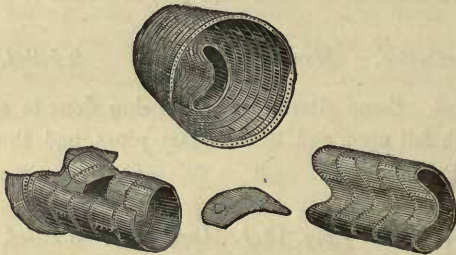
Fig. 14.

No. 16. *Cornwall.* (*Fig. 14.*) *April 18th.* *1 killed, 1 injured.*

One of two. Cornish, very old, 34ft. long, 6ft. diameter. Tube 3ft. 10in. diameter, $\frac{3}{8}$ inch plates, 50 lbs. pressure. The tube collapsed and the front part was blown out, and the boiler was forced back a little. It was said to have been short of water, but the weakness of a tube of such large diameter was most likely the true cause.

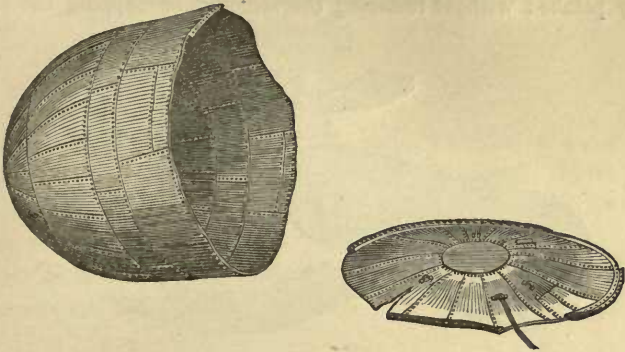
Fig. 15.

to $\frac{1}{8}$ inch, and temporarily repaired with screw patches, and was so reduced in strength that it gave way at the ordinary pressure.

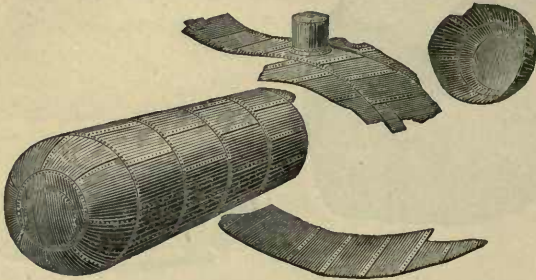
Fig. 17.

diameter, $\frac{7}{16}$ inch plates, 45 lbs. pressure. Gave way by the rent of a ripped seam over the fire, which had been repeatedly temporarily patched without restoring the strength or stopping the rip.

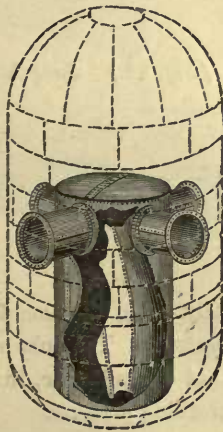
Fig. 20.

No. 23. *Kidsgrove.* (Fig. 20.) *May 26th.*

One of three. Four Furnace Upright, 12 years old, 17ft. 6in. high, 9ft. diameter. Centre tube 5ft. 9in. diameter, $\frac{3}{8}$ inch plates, 40 lbs. pressure. The centre tube was much corroded on the inside and collapsed inwards from consequent weakness, allowing the contents to issue at the bottom of the boiler, and the reaction sent the whole boiler high up into the air, and on to a roof causing great damage.

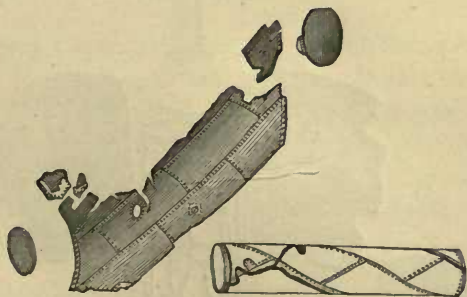
Fig. 25.

No. 29. *Nottingham.* (Fig. 25.) June 13th. 3 injured.

Ten years old. Plain cylinder, with flat ends, 10ft. long, 2ft. diameter, diagonal seams, $\frac{1}{4}$ inch plates, 25 lbs. pressure. The

whole shell was blown 80 yards to the front, and the chimney and engine house much damaged. It was much corroded and badly patched, so as to be unfit to carry pressure.

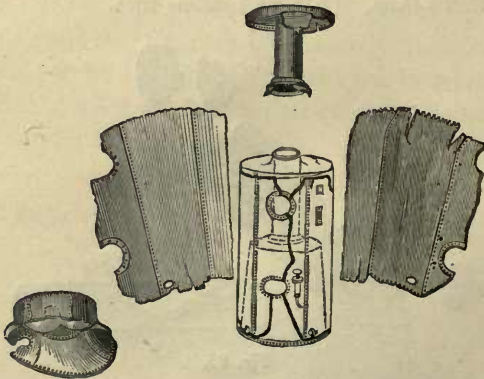
Fig. 27.

No. 31. *Glasgow.* (Fig. 27.) *June 17th.* none injured.

Crane Boiler, about 2 years old, 7ft. high, 4ft. diameter, $\frac{3}{8}$ inch

plates, 50 lbs. pressure. The internal fire box collapsed and the external shell was blown to pieces. There was no sign of shortness of water, but it is supposed that the fire box was not circular, and therefore too weak to bear the ordinary pressure.

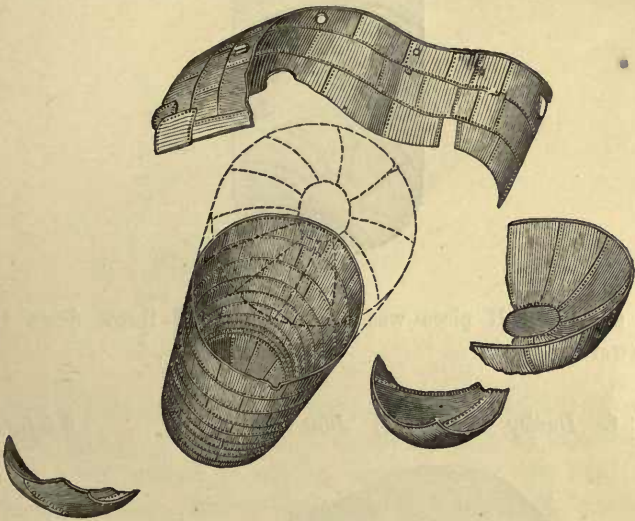
Fig. 28.

No. 32. *Bilston.* (Fig. 28.) *June 21st.* 2 killed, 6 injured.

One of seven. Plain cylinder, 30 years old, 30ft. long, 8ft. 3in. diameter, $\frac{1}{2}$ inch plates, 35 lbs. pressure. It gave way over fire place, where it had been weakened by frequent repair, which had caused a seam rip near a patch. The fragments were widely scattered, and much damage was done to the premises. The insecurity of boilers so frequently required with patch upon patch has been often pointed out.
